# Manhole Inspection Summary

Manhole # S43E\_\_041MH

Insp Date: **6/11/08 9:00 AM**

**Location** Address: **100 s register st**

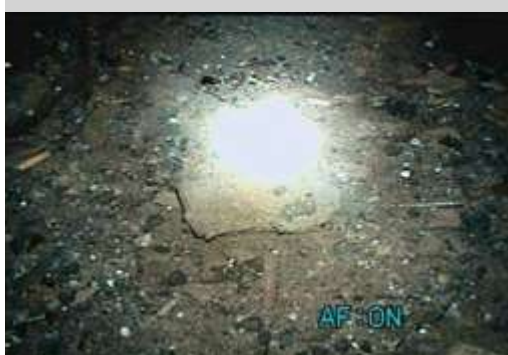
Defect 2

Condition: ☐ Sound ☐ Cracked ☐ Root Intrusion ☐ Deteriorated ☐ Leaks ☒ **Debris**

channel debris

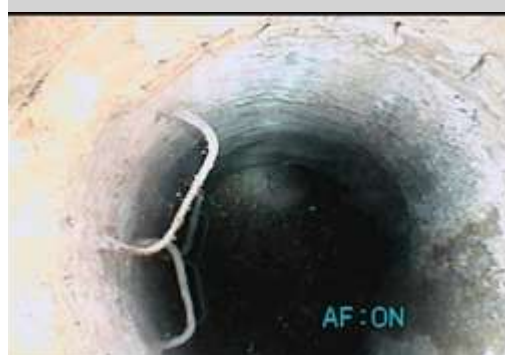
Defect

Count: **6** Missing: **0** ☒ **Corroded**

corroded steps

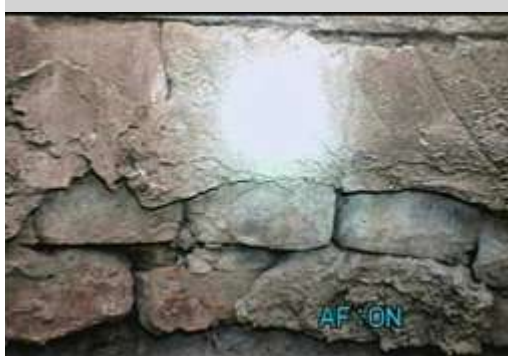
Defect 1

Condition: ☐ Sound ☐ Cracked ☐ Root Intrusion ☒ **Loose Brick** ☐ Deteriorated

Chimney loose bricks,  
frame adj

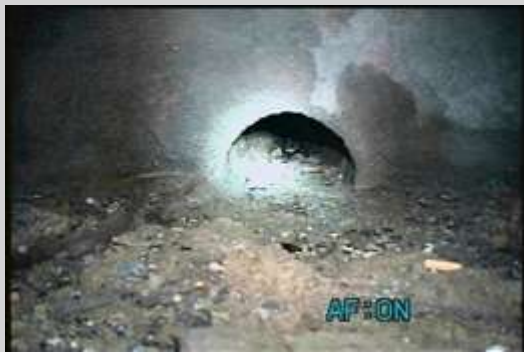
12 O'Clock Outflow

8 in. Circular Gravity Sewer  
Pipe Out @ 12 O'Clock

Deposits: ☐ None ☐ Mud ☐ Sludge ☒ **Debris** ☐ Grease
